Examination of Failed Components From District of Columbia Incinerator No. 5

Failure Analysis Report

Prepared for
Construction and Repair Division
Department of Environmental Services
Government of the District of Columbia 20019

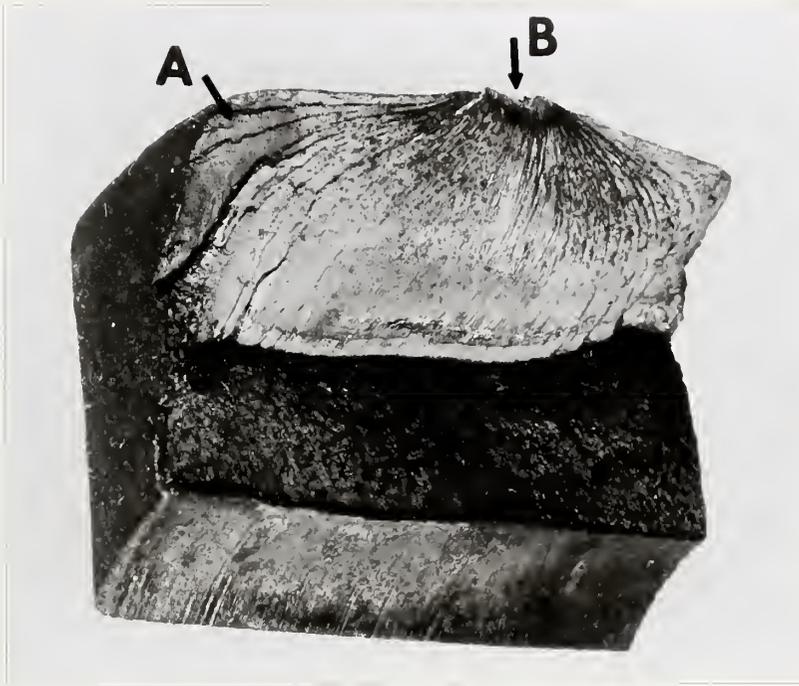
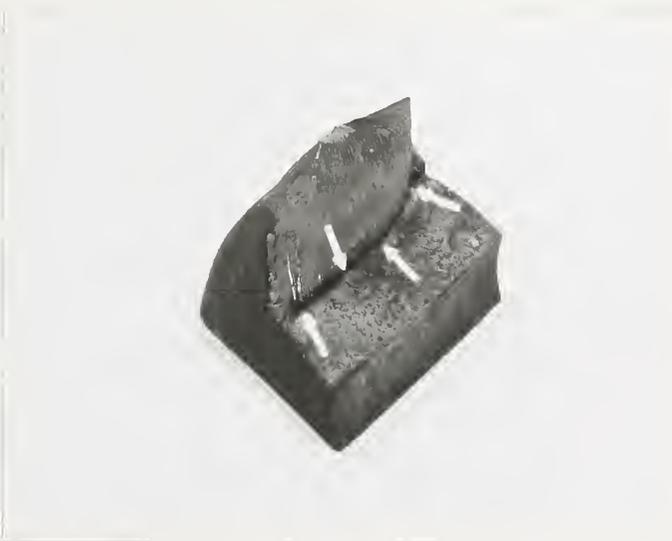
Figure 24. Fracture surface of one of the failed chain links.

The second chain link fracture surface examined is shown in figure 24. The part of the fracture surface adjacent to the outside surface of the chain link was fibrous in nature (upper part of fracture surface shown in figure 24a). Part way through, the fracture surface makes a sharp change in direction (arrows in figure 24b), and the part of the fracture surface adjacent to the inside surface of the chain link is flat and smoother than the fibrous part. There appears to have been a pre-existing crack (dark part of fracture surface indicated by arrow A, figure 24a). This may have been a quenching crack which formed during heat treatment of the link. It appears that the fracture probably initiated at the outside surface of the link (arrow B, figure 24a), and propagated inward, passing through the pre-existing crack. The fracture in this chain link probably occurred from either impact or overload.
